**Flood Control Project Maintenance
Levee Inspections
LMA District Cover Sheet
Spring 2010 Levee Inspection Results**

San Joaquin County Flood Control and Water Conservation District

Spring 2010 Levee Inspection Results

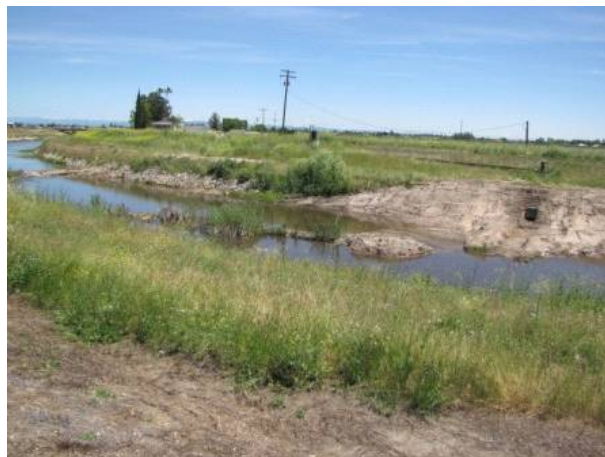
Levee Mile Report Line	96
Start Levee Mile	12.16
End Levee Mile	12.16
Location	Water Side
Category	Channels
Item	Shoaling / Sedimentation

View of sediment in the channel remaining after stream cleaning.

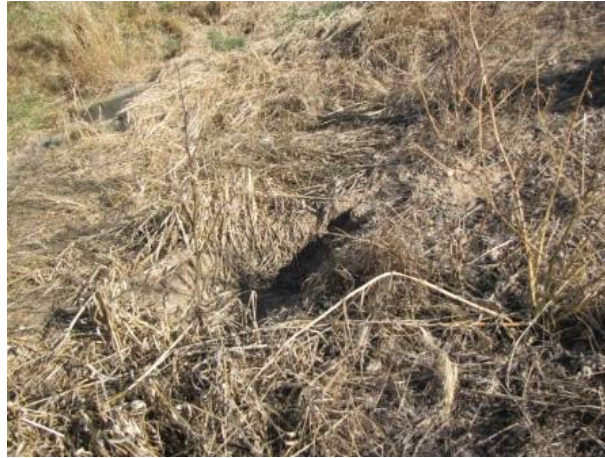
dpesaven_s_20100518_603.jpg

View of a depression in the landward slope.

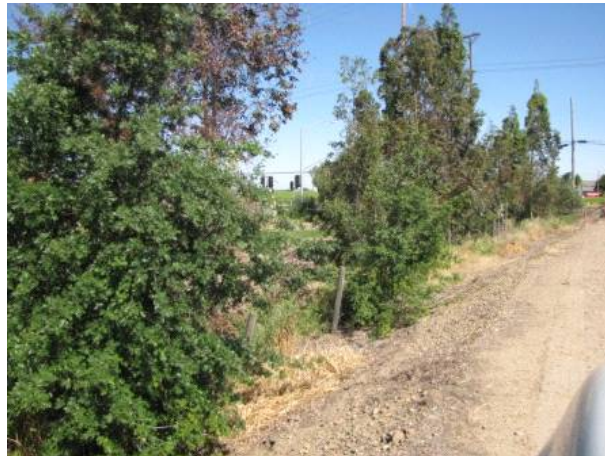
Levee Mile Report Line	103
Start Levee Mile	13.22
End Levee Mile	13.22
Location	Land Side
Category	Earthen Levee
Item	Trim / Thin Trees

View of trees blocking visibility along the landward toe looking upstream.

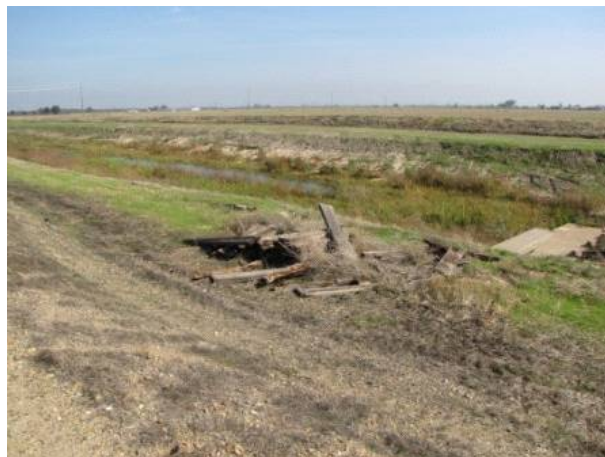
Levee Mile Report Line	105
Start Levee Mile	13.33
End Levee Mile	13.33
Location	Water Side
Category	Earthen Levee
Item	Encroachments

View of debris from the flapboard dam on the waterward slope.

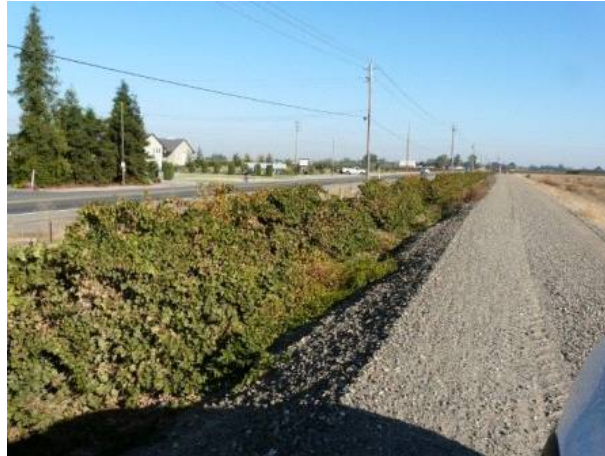
dpesaven_s_20100316_027.JPG

Grape vines within 10' from landside toe of levee from LM 13.39 to 13.51.

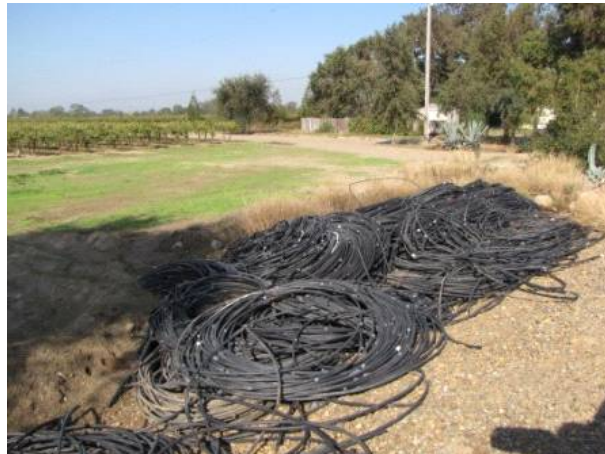
Levee Mile Report Line	111
Start Levee Mile	13.99
End Levee Mile	13.99
Location	Land Side
Category	Earthen Levee
Item	Encroachments

View of irrigation pipe on the landward slope.

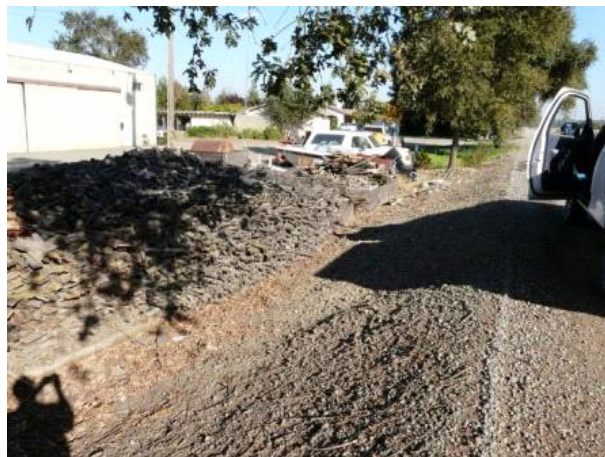
dpesaven_s_20100316_028.JPG

Move firewood to outside of 10' from landside toe of levee at LM 14.08.

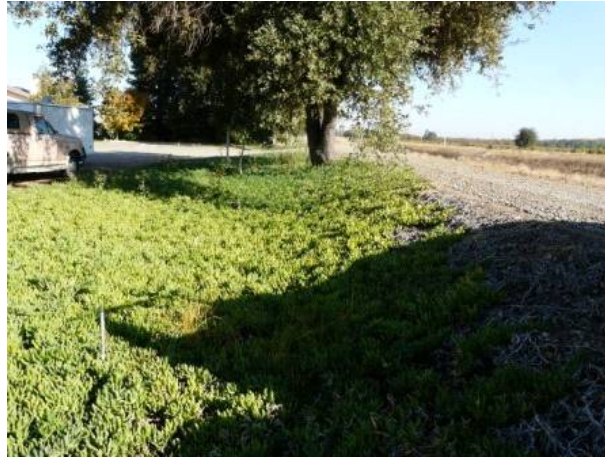
dpesaven_s_20100316_029.JPG

Landscaping on landside of levee from LM 14.09 to LM 14.13.

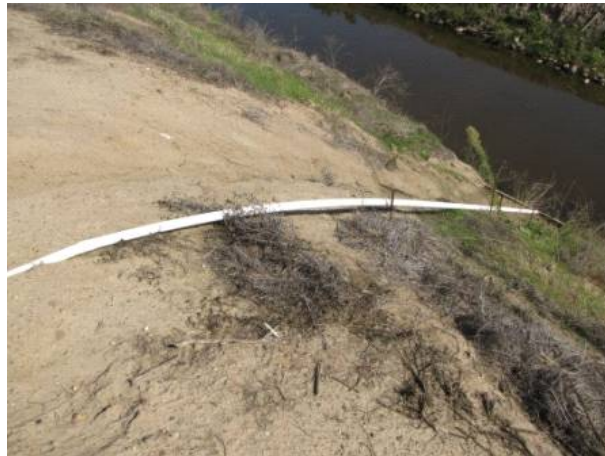
Levee Mile Report Line	118
Start Levee Mile	14.77
End Levee Mile	14.77
Location	Water Side
Category	Earthen Levee
Item	Encroachments

View of a pipe a landowner placed in the access road and waterward slope to pump water from the channel to irrigate their garden.

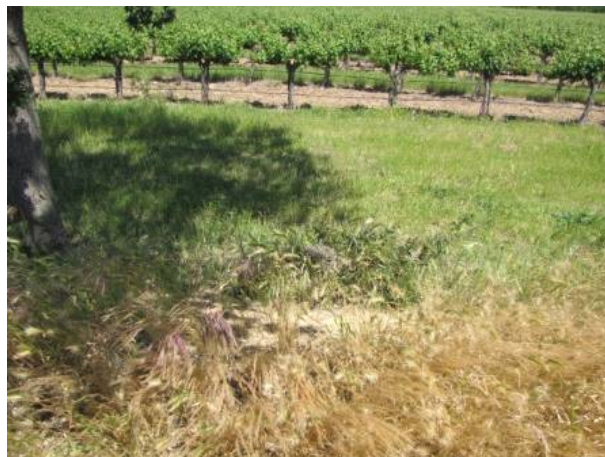
Levee Mile Report Line	121
Start Levee Mile	15.72
End Levee Mile	15.72
Location	Land Side
Category	Earthen Levee
Item	Trim / Thin Trees

View of a stump in the landward slope.

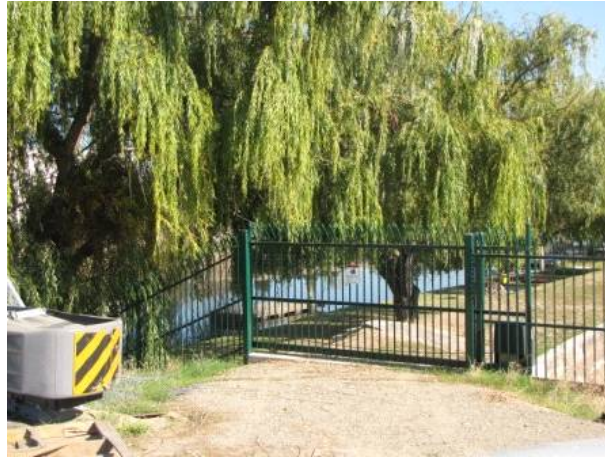
dpesaven_s_20100316_169.jpg

View of a open fence and gate across the crown at the current start of the unit looking upstream. Limited access has been provided.

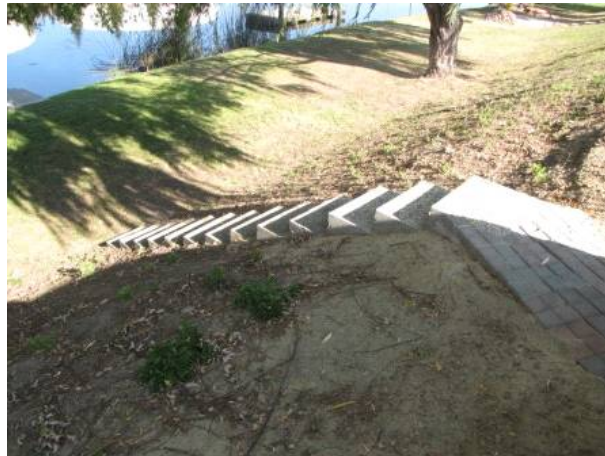
Levee Mile Report Line	5
Start Levee Mile	0.78
End Levee Mile	0.78
Location	Water Side
Category	Earthen Levee
Item	Encroachments

View of steps on the waterward slope of the levee looking upstream.

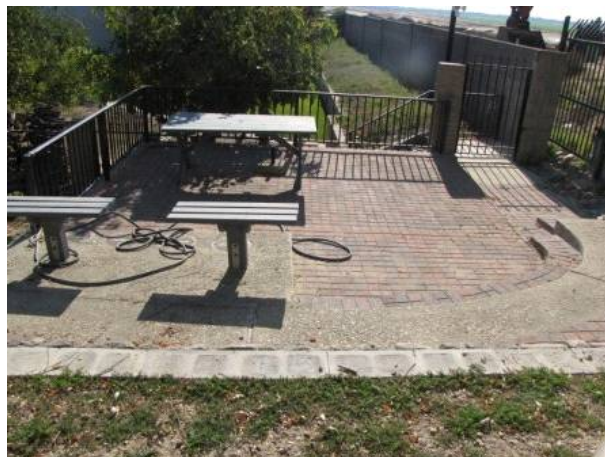
Levee Mile Report Line	6
Start Levee Mile	0.78
End Levee Mile	0.79
Location	Land Side
Category	Earthen Levee
Item	Encroachments

6	0.78	0.79	Earthen Levee	Encroachments	LS	PO	Buildings Inspector Comments: Patio with benches, table, fence, and steps. Utility valve boxes noted.	38.053178 ° -121.375387 °	38.053178 ° -121.375387 °	1056 Y
7	0.78	0.79	Earthen Levee	Encroachments	WS	PO	Landscaping Inspector Comments: Iceplant and irrigation system on waterward side. Spring 2010 Update: Landscaping has been removed from waterward slope, irrigation still exists.	38.053178 ° -121.375387 °	38.053178 ° -121.375387 °	1059 Y
8	0.79	0.79	Earthen Levee	Encroachments	WS	PO	Buildings Inspector Comments: Dock on waterward berm.	38.053178 ° -121.375387 °	38.053178 ° -121.375387 °	1057 Y
9	0.79	0.79	Earthen Levee	Encroachments	LS	M	Stairways	38.053178 ° -121.375387 °	38.053178 ° -121.375387 °	1058 Y
10	0.79	0.81	Earthen Levee	Encroachments	LS	PO	Fences Inspector Comments: Fence and small retaining wall with landscaping and irrigation cut into the landward toe.	38.053178 ° -121.375387 °	38.053178 ° -121.375387 °	1060 Y

View of a patio with table, benches, and irrigation on the landward side of the levee.

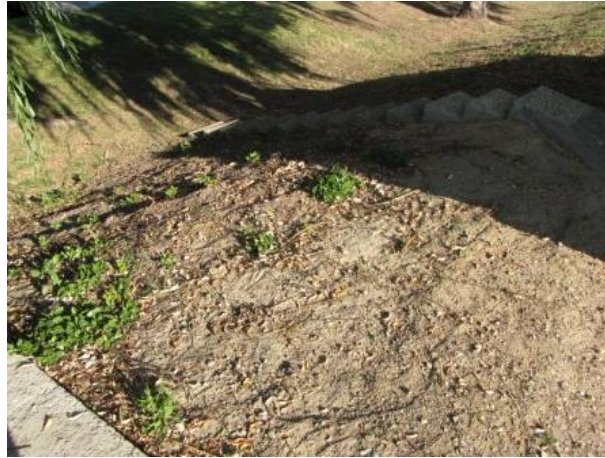
dpesaven_s_20100316_174.jpg

View of landscaping and irrigation on the waterward slope.

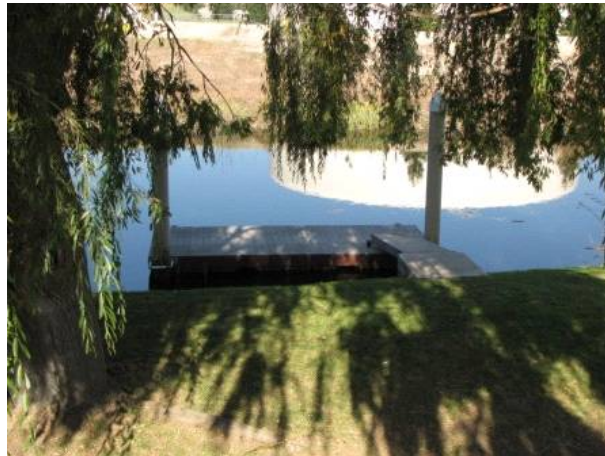
Levee Mile Report Line	8
Start Levee Mile	0.79
End Levee Mile	0.79
Location	Water Side
Category	Earthen Levee
Item	Encroachments

View of a dock off the waterward berm.

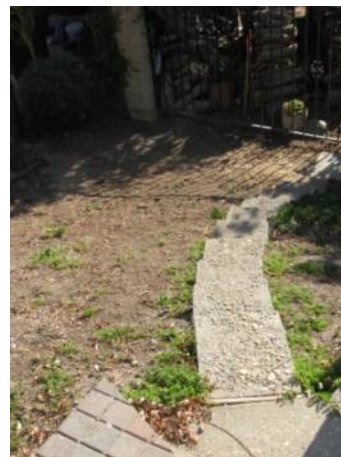
Levee Mile Report Line	9
Start Levee Mile	0.79
End Levee Mile	0.79
Location	Land Side
Category	Earthen Levee
Item	Encroachments

View of steps on the landward slope of the levee.

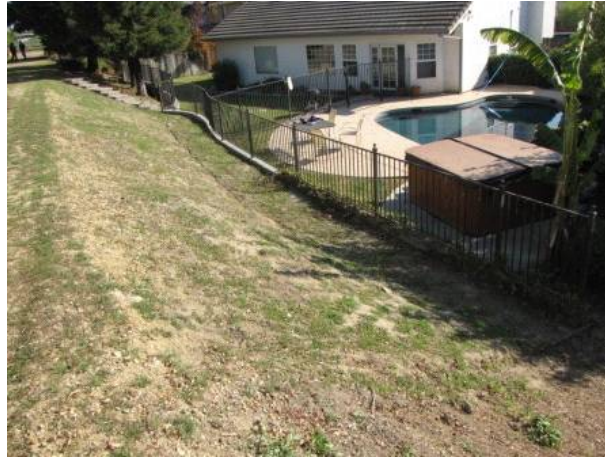
dpesaven_s_20100316_175.jpg

View of a fence on top of a retaining wall in the landward toe of the levee. Some landscaping and irrigation are also present.

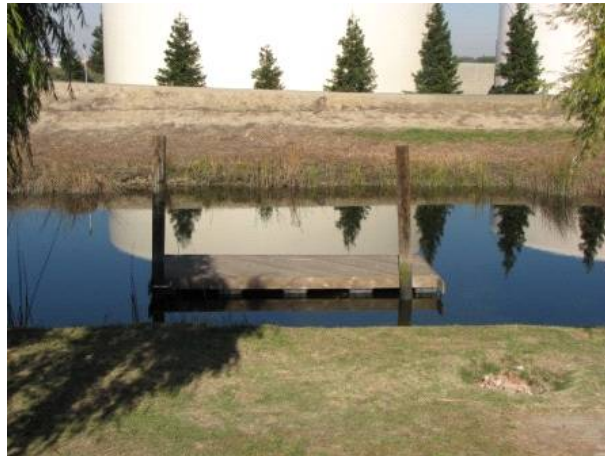
Levee Mile Report Line	11
Start Levee Mile	0.80
End Levee Mile	0.80
Location	Water Side
Category	Earthen Levee
Item	Encroachments

View of a dock off the waterward side of the berm.

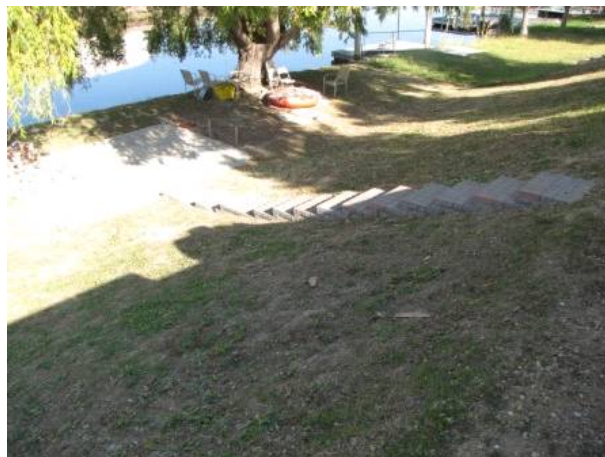
Levee Mile Report Line	12
Start Levee Mile	0.80
End Levee Mile	0.80
Location	Water Side
Category	Earthen Levee
Item	Encroachments

View of stairs and patio on the waterward slope and berm looking upstream.

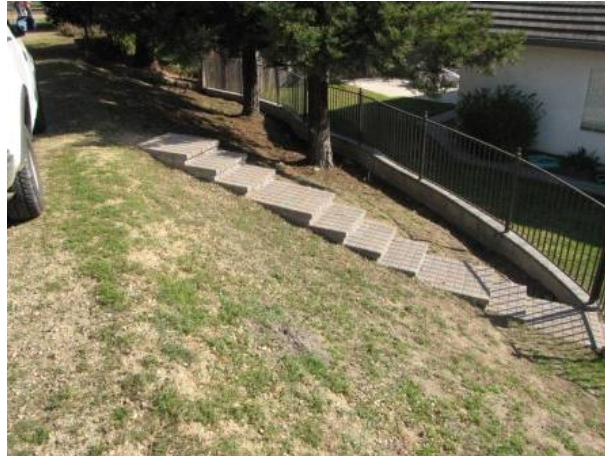
Levee Mile Report Line	13
Start Levee Mile	0.80
End Levee Mile	0.80
Location	Land Side
Category	Earthen Levee
Item	Encroachments
View of steps on the landward slope looking upstream.	
dpesaven_s_20100316_190.jpg

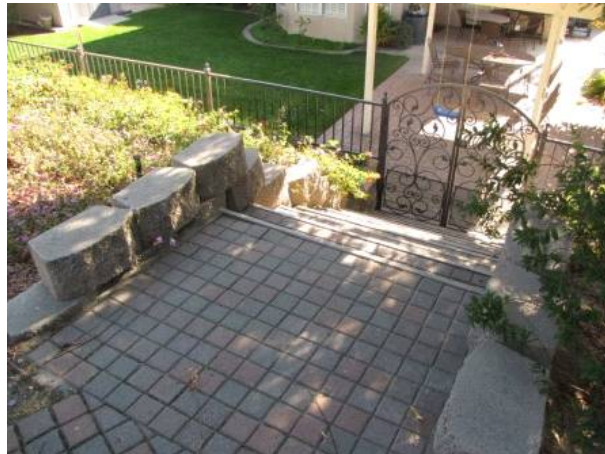
Levee Mile Report Line	14
Start Levee Mile	0.81
End Levee Mile	0.81
Location	Land Side
Category	Earthen Levee
Item	Encroachments
View of steps on the landward slope.	
dpesaven_s_20100316_180.jpg

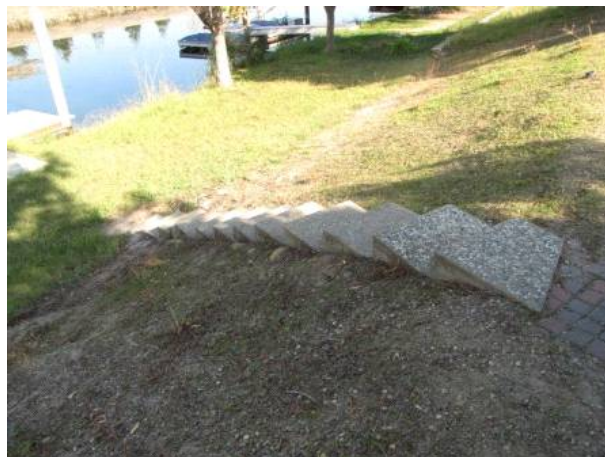
Levee Mile Report Line	15
Start Levee Mile	0.81
End Levee Mile	0.81
Location	Water Side
Category	Earthen Levee
Item	Encroachments
View of steps on the waterward slope looking upstream.	
dpesaven_s_20100316_181.jpg

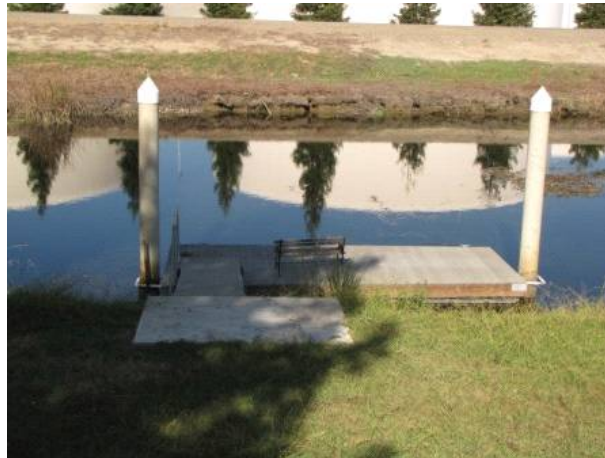
dpesaven_s_20100316_182.jpg

View of a dock on the waterward side of the berm.

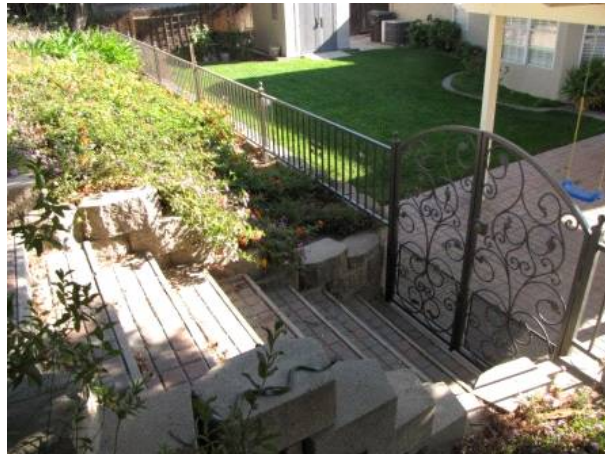
Levee Mile Report Line	17
Start Levee Mile	0.81
End Levee Mile	0.82
Location	Land Side
Category	Earthen Levee
Item	Encroachments

View of a open fence on a retaining wall in the landward toe of the levee looking upstream.

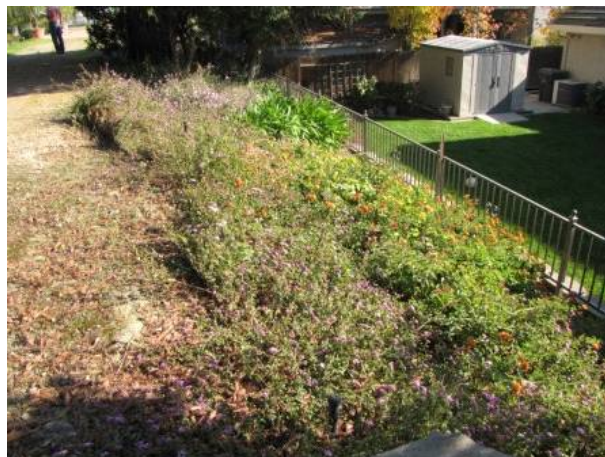
Levee Mile Report Line	18
Start Levee Mile	0.81
End Levee Mile	0.82
Location	Land Side
Category	Earthen Levee
Item	Encroachments

View of landscaping obstructing visibility and access and irrigation along the landward slope looking upstream.

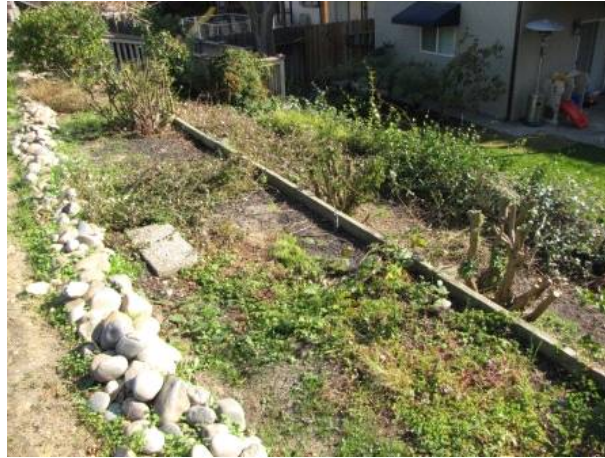
dpesaven_s_20100316_183.jpg

View of landscaping and irrigation along the landward slope looking upstream.

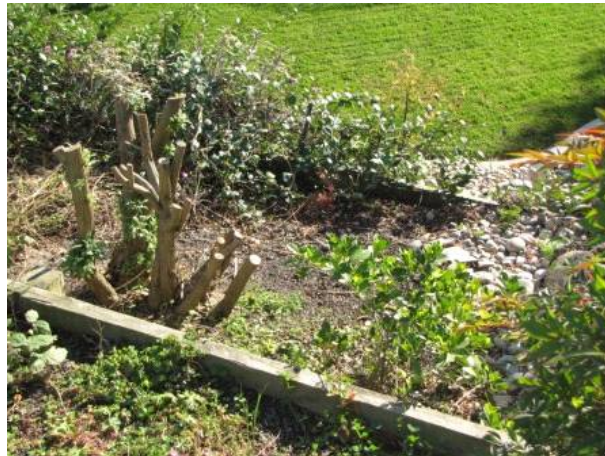
Levee Mile Report Line	21
Start Levee Mile	0.82
End Levee Mile	0.83
Location	Land Side
Category	Earthen Levee
Item	Encroachments

View of wood retaining walls created landscaping terraces.

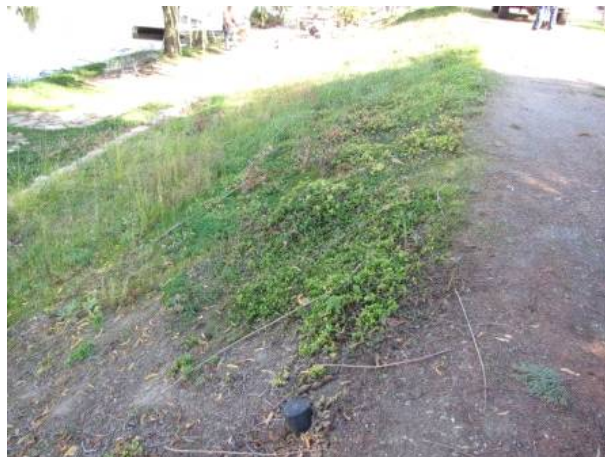
Levee Mile Report Line	23
Start Levee Mile	0.82
End Levee Mile	0.83
Location	Water Side
Category	Earthen Levee
Item	Encroachments

View of landscaping and irrigation on the waterward slope looking upstream.

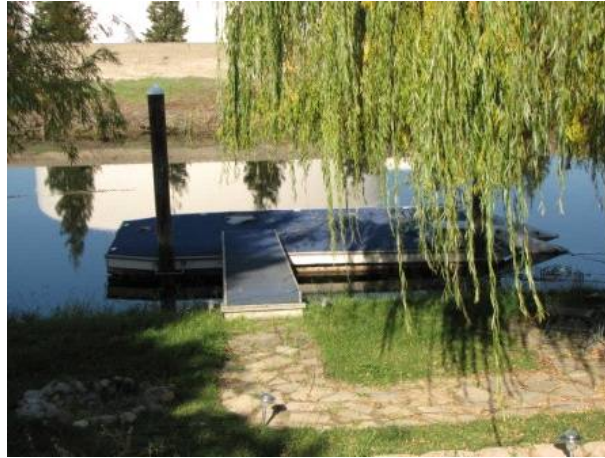
dpesaven_s_20100316_187.jpg

View of a dock and pathway on the waterward side of the berm.

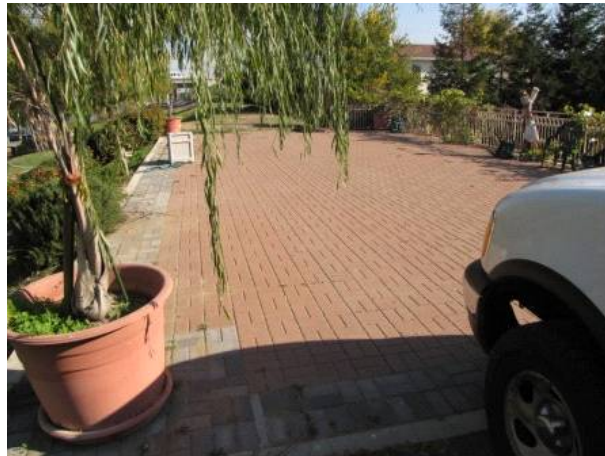
Levee Mile Report Line	25
Start Levee Mile	0.83
End Levee Mile	0.84
Location	Crown
Category	Earthen Levee
Item	Encroachments

View of pavers placed on the crown of the levee looking upstream. Potted landscaping and irrigation can also be seen.

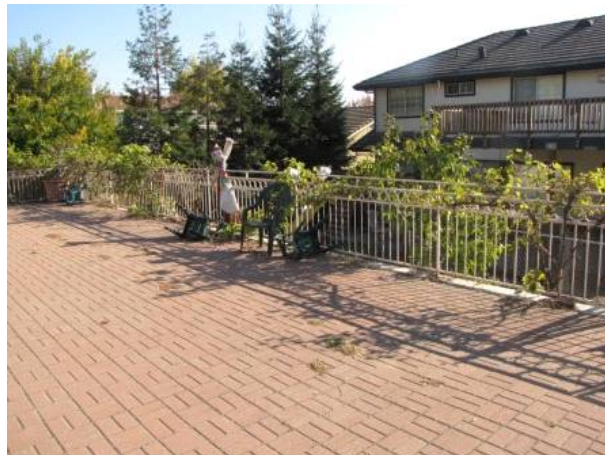
Levee Mile Report Line	26
Start Levee Mile	0.83
End Levee Mile	0.84
Location	Land Side
Category	Earthen Levee
Item	Encroachments

View of a fence on top of a large retaining wall in the landward slope looking upstream. Landscaping is growing along the fence.

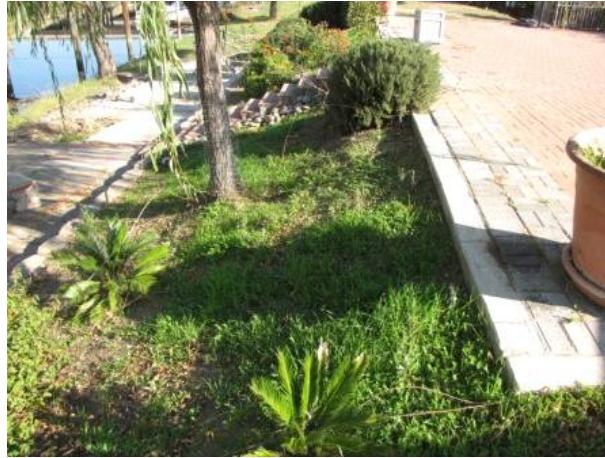
dpesaven_s_20100316_194.jpg

View of landscaping and irrigation on the waterward slope looking upstream.

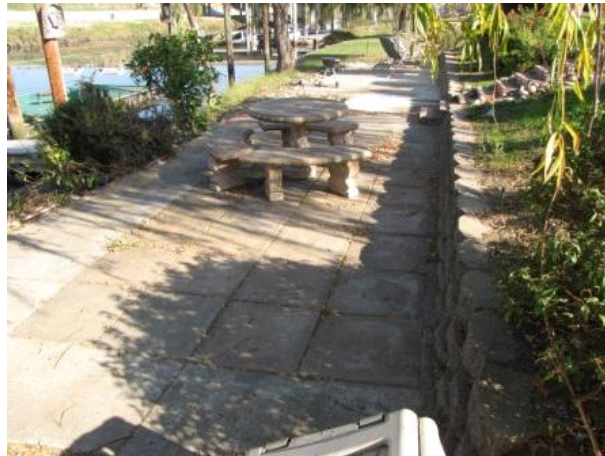
Levee Mile Report Line	28
Start Levee Mile	0.83
End Levee Mile	0.84
Location	Water Side
Category	Earthen Levee
Item	Encroachments

View of a retaining wall and patio with furniture in the waterward toe and berm looking upstream.

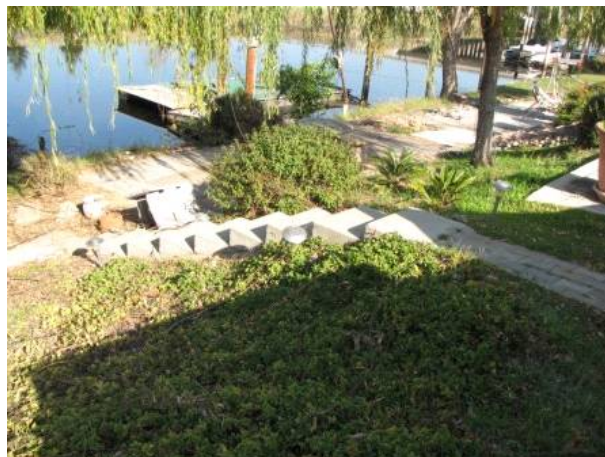
Levee Mile Report Line	30
Start Levee Mile	0.83
End Levee Mile	0.83
Location	Water Side
Category	Earthen Levee
Item	Encroachments

View of steps on the waterward slope looking upstream.

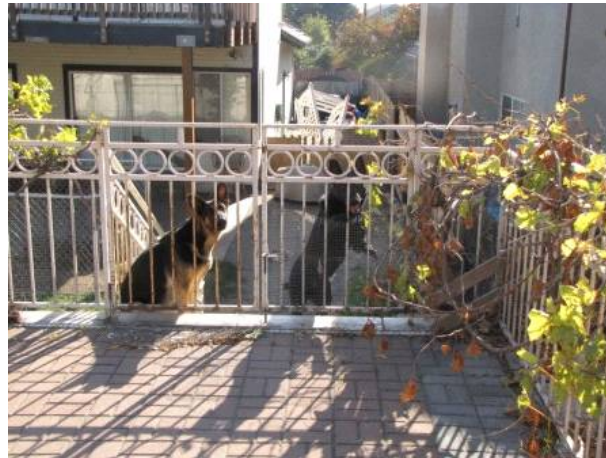
dpesaven_s_20100316_193.jpg

View of steps on the landward slope and dogs preventing a closer inspection.

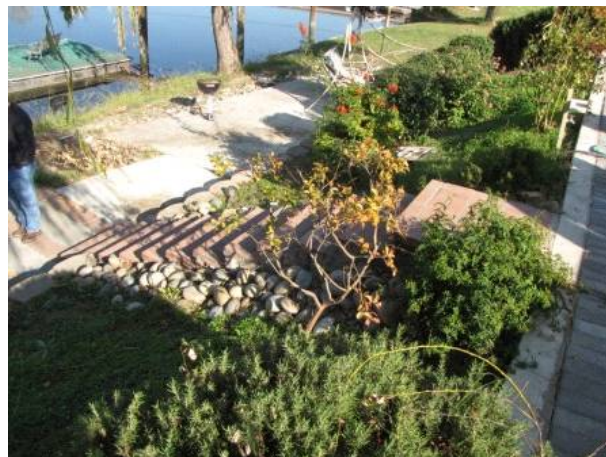
Levee Mile Report Line	32
Start Levee Mile	0.84
End Levee Mile	0.84
Location	Water Side
Category	Earthen Levee
Item	Encroachments

View of steps on the waterward slope of the levee looking upstream.

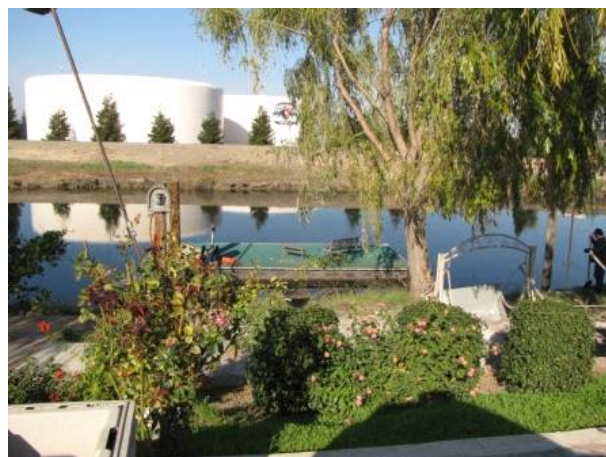
Levee Mile Report Line	33
Start Levee Mile	0.84
End Levee Mile	0.84
Location	Water Side
Category	Earthen Levee
Item	Encroachments

View of a dock on the waterward side of the berm.

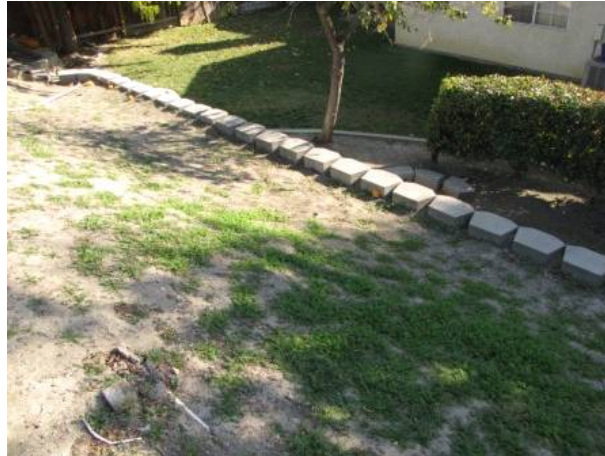
dpesaven_s_20100316_198.jpg

View of a retaining wall in the landward slope.

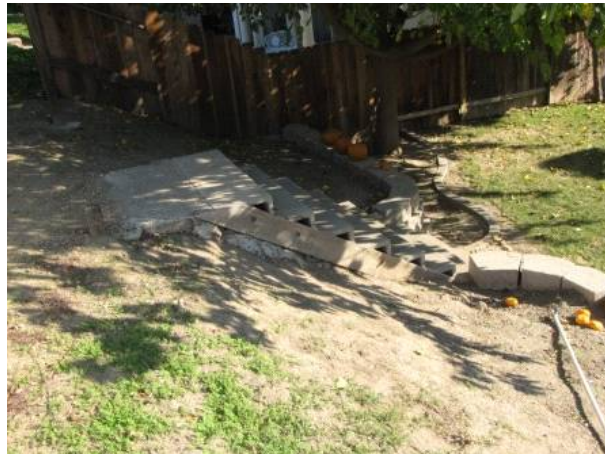
Levee Mile Report Line	38
Start Levee Mile	0.85
End Levee Mile	0.85
Location	Land Side
Category	Earthen Levee
Item	Encroachments

View of steps on the landward slope looking upstream.

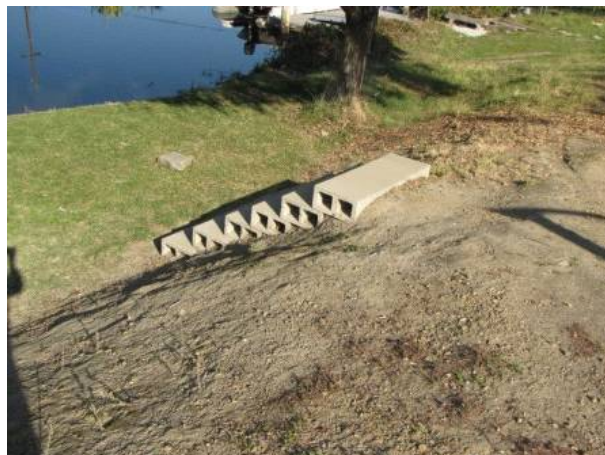
Levee Mile Report Line	39
Start Levee Mile	0.85
End Levee Mile	0.85
Location	Water Side
Category	Earthen Levee
Item	Encroachments

View of steps on the waterward slope looking upstream.

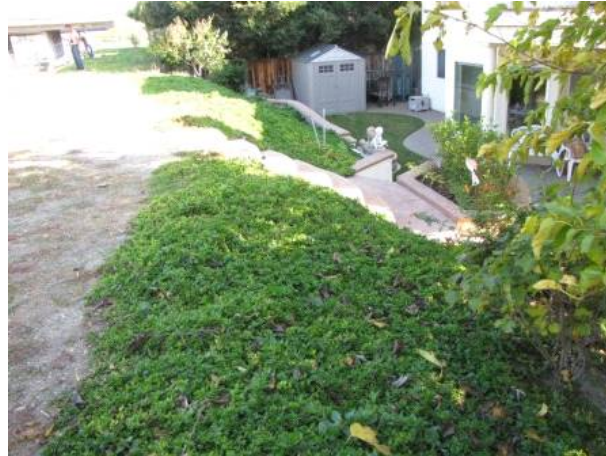
dpesaven_s_20100316_202.jpg

View of landscaping and irrigation on the landward slope looking upstream.

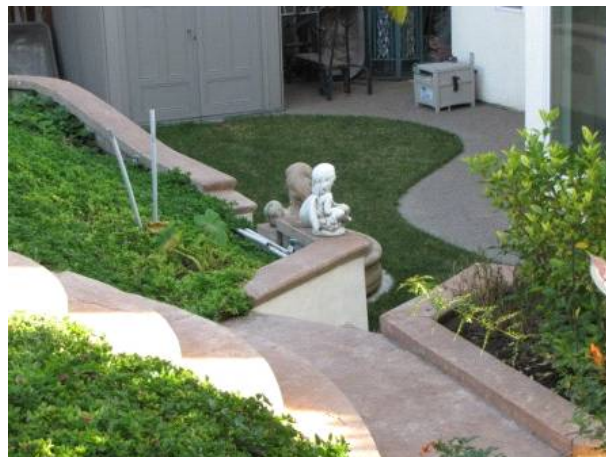
Levee Mile Report Line	41
Start Levee Mile	0.85
End Levee Mile	0.87
Location	Land Side
Category	Earthen Levee
Item	Encroachments

View of a retaining wall and patio in the landward slope.

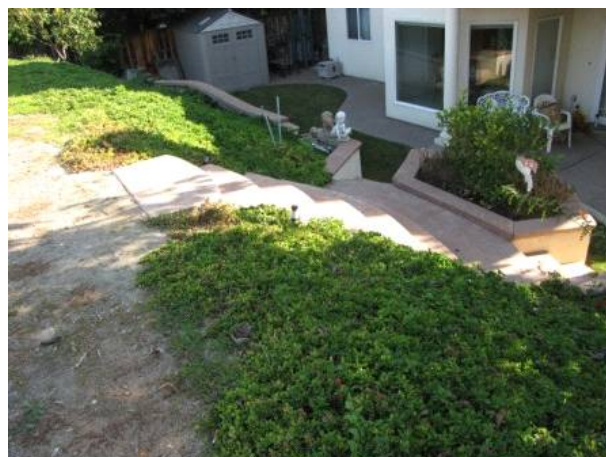
Levee Mile Report Line	42
Start Levee Mile	0.86
End Levee Mile	0.86
Location	Land Side
Category	Earthen Levee
Item	Encroachments

View of steps on the landward slope looking upstream.

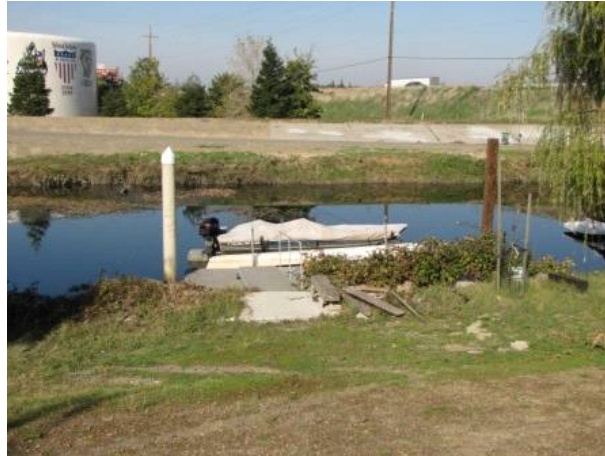
dpesaven_s_20100316_205.jpg

View of a dock and concrete pad on the waterward side of the berm.

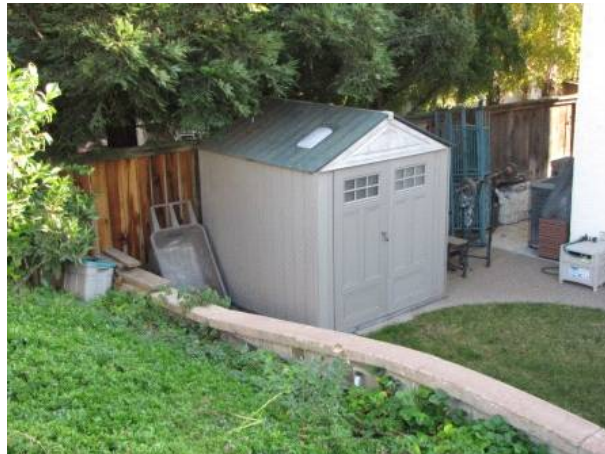
Levee Mile Report Line	44
Start Levee Mile	0.87
End Levee Mile	0.87
Location	Land Side
Category	Earthen Levee
Item	Encroachments

View of a shed located at the landward toe looking upstream.

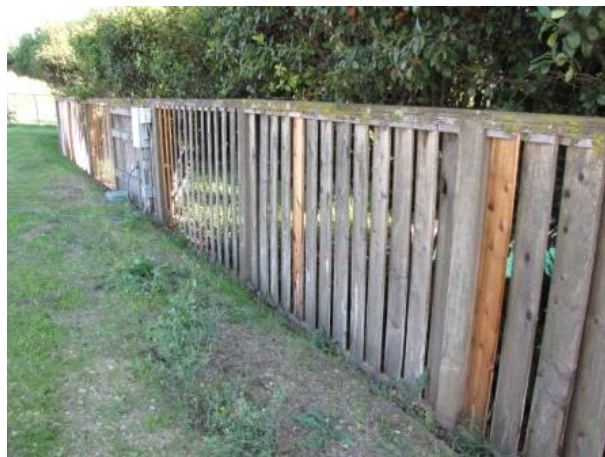
Levee Mile Report Line	45
Start Levee Mile	0.87
End Levee Mile	0.88
Location	Land Side
Category	Earthen Levee
Item	Encroachments

View of a fence at the landward shoulder blocking visibility and access looking upstream. Some encroachments can be seen through the fence but not with any detail. Also visible is an electrical panel and hose bib.

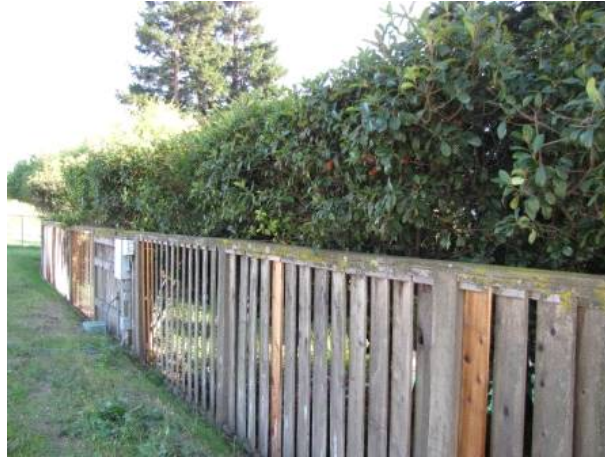
View of bushes above the fence at the landward shoulder further obstructing visibility looking upstream.

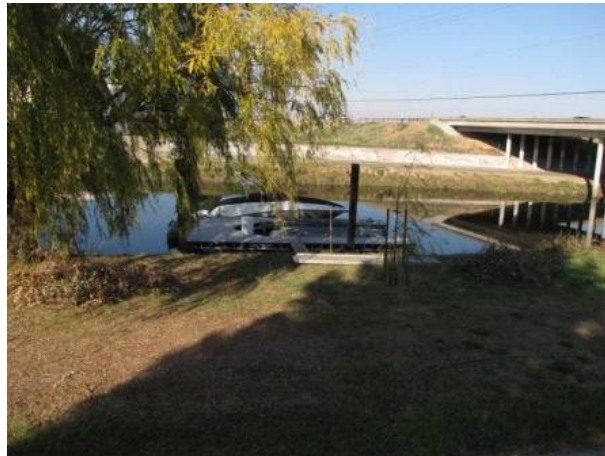
Levee Mile Report Line	47
Start Levee Mile	0.88
End Levee Mile	0.88
Location	Water Side
Category	Earthen Levee
Item	Encroachments

View of a dock on the waterward side of the berm.

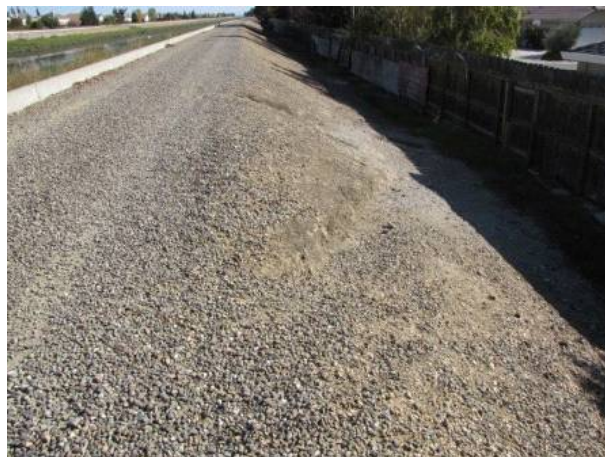
Levee Mile Report Line	50
Start Levee Mile	1.00
End Levee Mile	1.00
Location	Land Side
Category	Earthen Levee
Item	Encroachments

View of steps dug into the landward slope looking upstream.

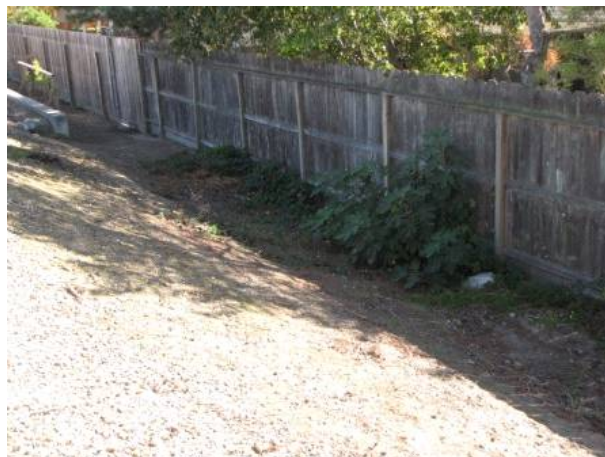
View of landowner maintained vegetation at the landward toe.

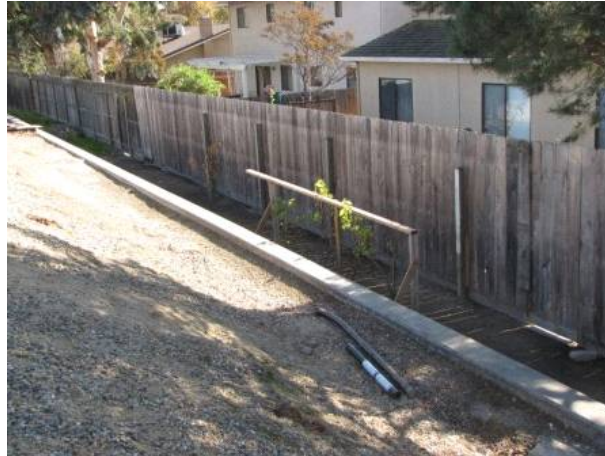
View of landowner maintained landscaping at the landward toe looking upstream.

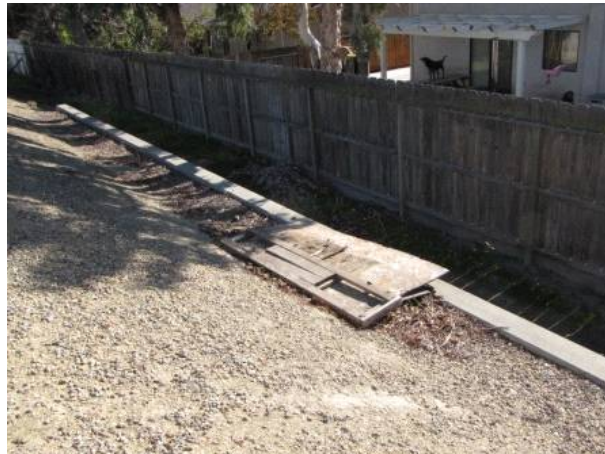
Levee Mile Report Line	56
Start Levee Mile	1.18
End Levee Mile	1.18
Location	Land Side
Category	Earthen Levee
Item	Encroachments

View of debris on the landward slope.

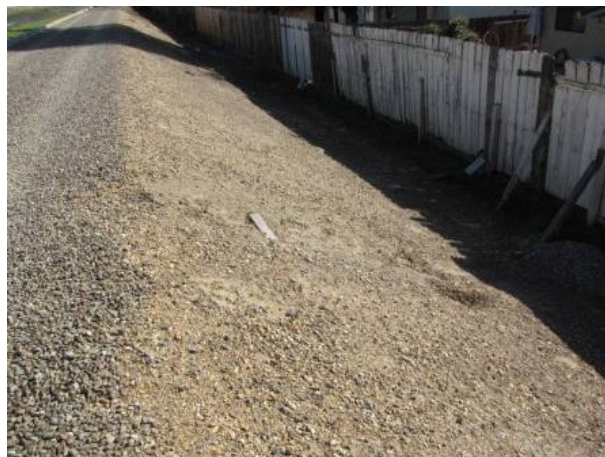
Levee Mile Report Line	57
Start Levee Mile	1.20
End Levee Mile	1.20
Location	Land Side
Category	Earthen Levee
Item	Encroachments

View of steps dug into the landward slope looking upstream.

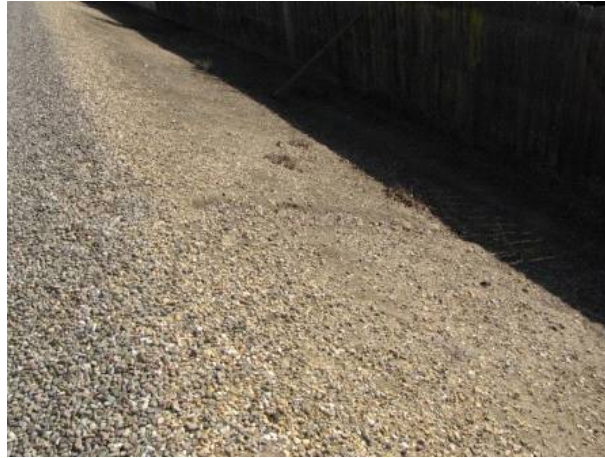
View of steps dug into the landward slope looking upstream.

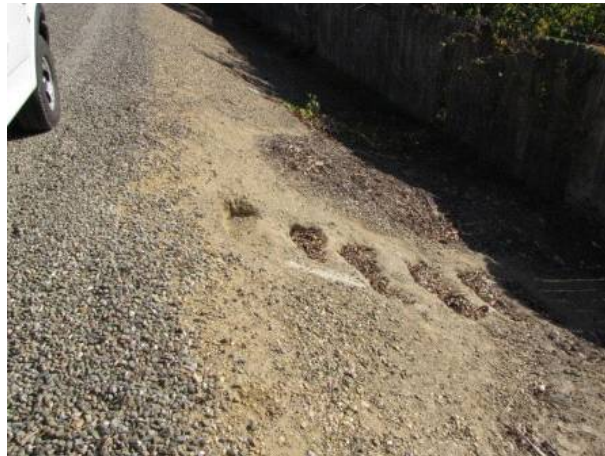
Levee Mile Report Line	60
Start Levee Mile	1.34
End Levee Mile	1.34
Location	Land Side
Category	Earthen Levee
Item	Encroachments

View of steps dug into the landward slope looking upstream.

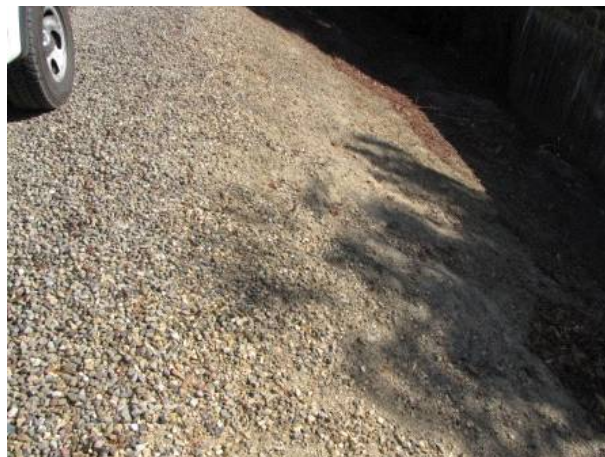
Levee Mile Report Line	61
Start Levee Mile	1.36
End Levee Mile	1.36
Location	Land Side
Category	Earthen Levee
Item	Encroachments

View of steps dug into the landward slope looking upstream.

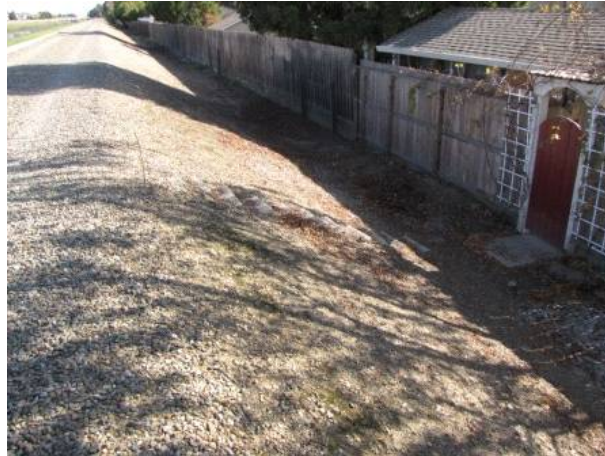
View of steps dug into the landward slope looking upstream.

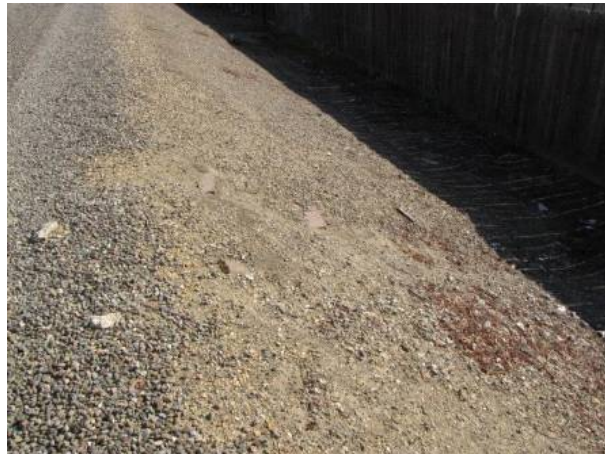
Levee Mile Report Line	63
Start Levee Mile	1.42
End Levee Mile	1.42
Location	Land Side
Category	Earthen Levee
Item	Encroachments

View of steps dug into the landward slope looking upstream.

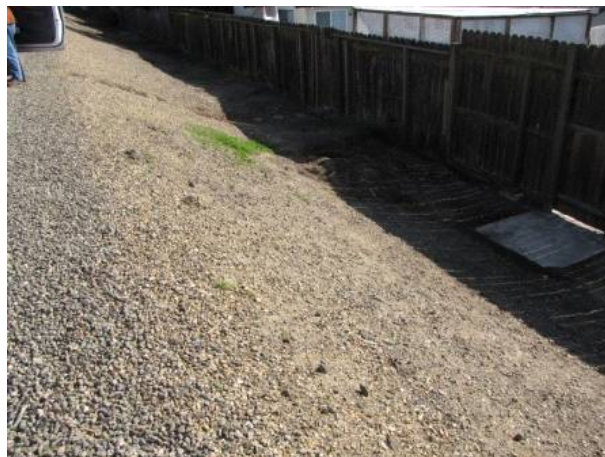
Levee Mile Report Line	64
Start Levee Mile	1.44
End Levee Mile	1.44
Location	Land Side
Category	Earthen Levee
Item	Slope Stability

View of a concrete pad at the landward toe cut into the slope.

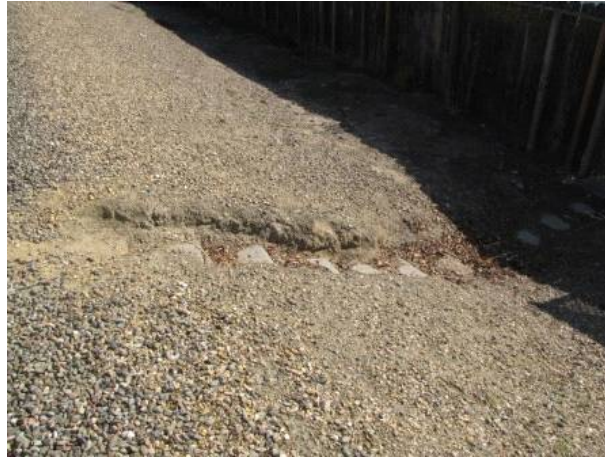
View of steps dug into the landward slope looking upstream.

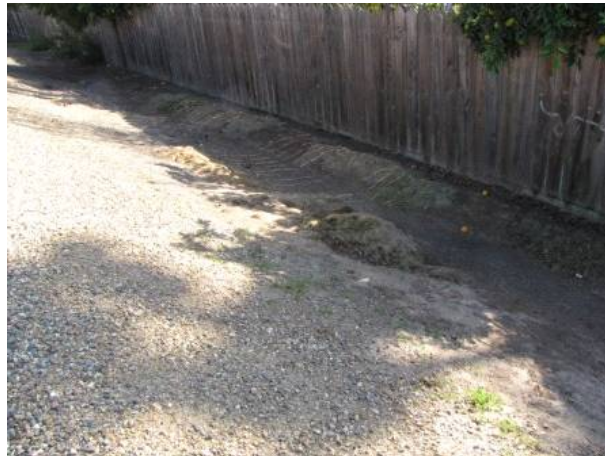
Levee Mile Report Line	66
Start Levee Mile	1.47
End Levee Mile	1.47
Location	Land Side
Category	Earthen Levee
Item	Encroachments

View of lawn clippings placed at the landward toe.

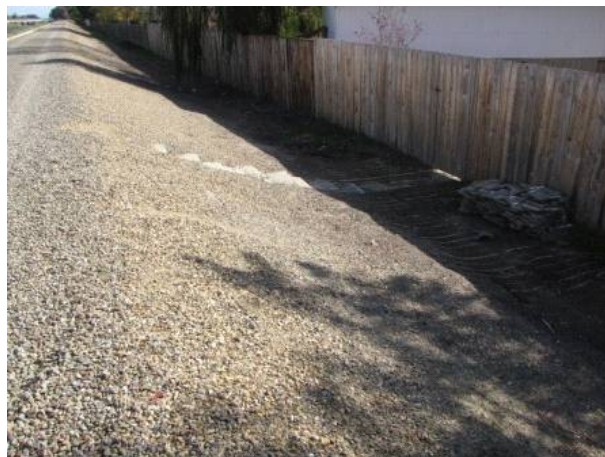
Levee Mile Report Line	67
Start Levee Mile	1.51
End Levee Mile	1.51
Location	Land Side
Category	Earthen Levee
Item	Encroachments

View of steps dug into the landward slope looking upstream.

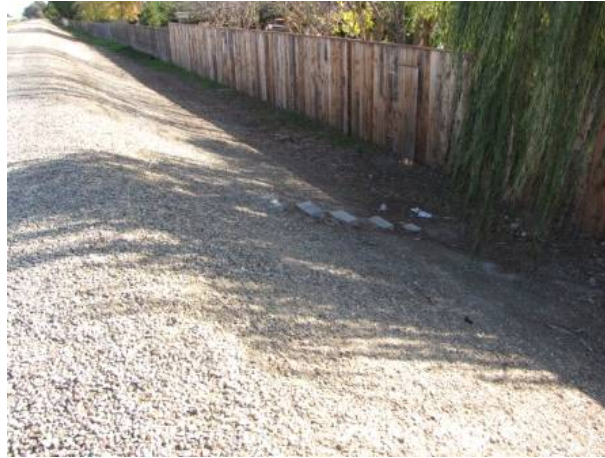
View of steps dug into the landward slope looking upstream.

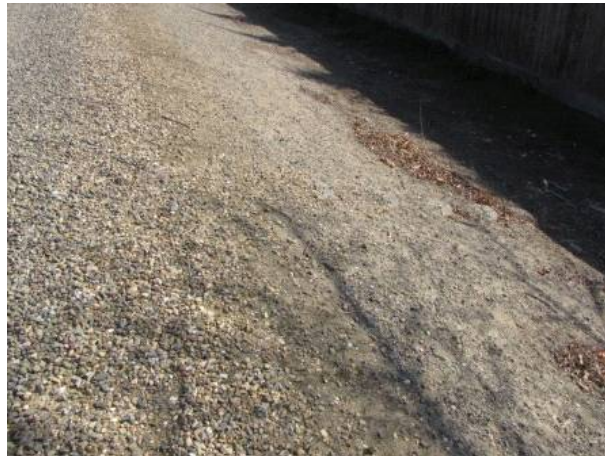
Levee Mile Report Line	69
Start Levee Mile	1.53
End Levee Mile	1.53
Location	Land Side
Category	Earthen Levee
Item	Encroachments

View of steps dug into the landward slope looking upstream.

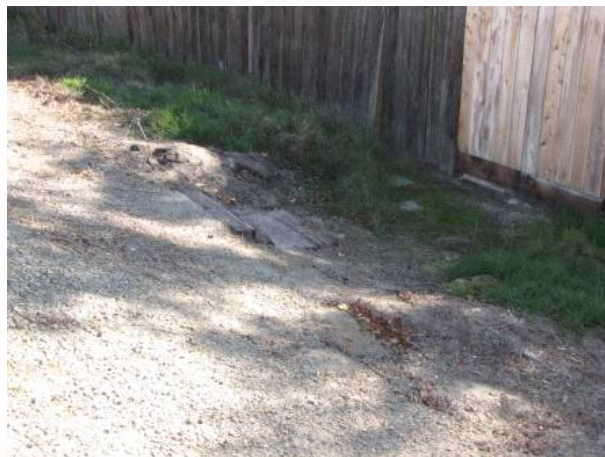
Levee Mile Report Line	70
Start Levee Mile	1.71
End Levee Mile	1.71
Location	Land Side
Category	Earthen Levee
Item	Encroachments

View of steps dug into the landward slope looking upstream.

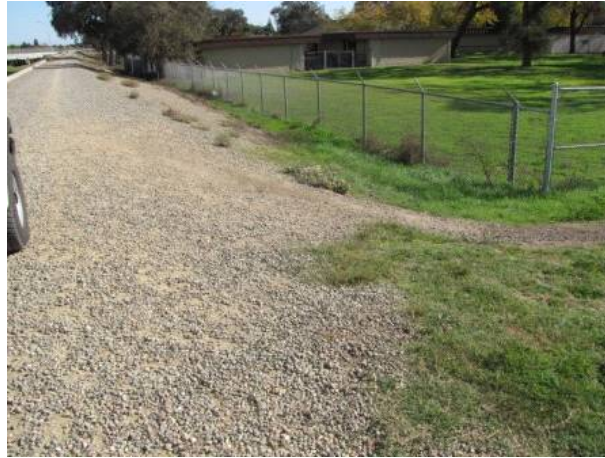
View of steps dug into the landward slope looking upstream.

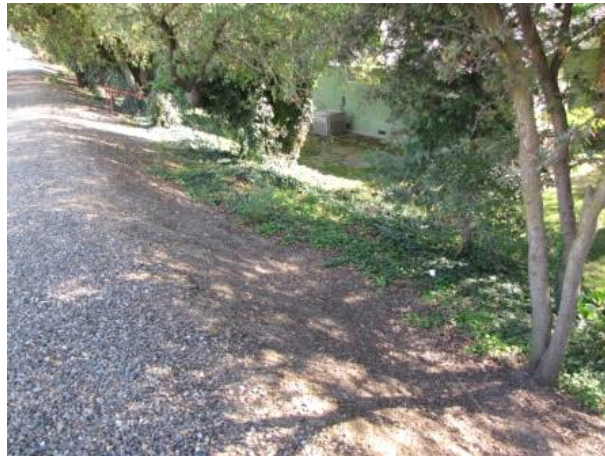
Levee Mile Report Line	74
Start Levee Mile	2.04
End Levee Mile	2.07
Location	Land Side
Category	Earthen Levee
Item	Encroachments

View of landscaping along the landward slope looking upstream. County crews have greatly reduced the amount of material and increased visibility and access.

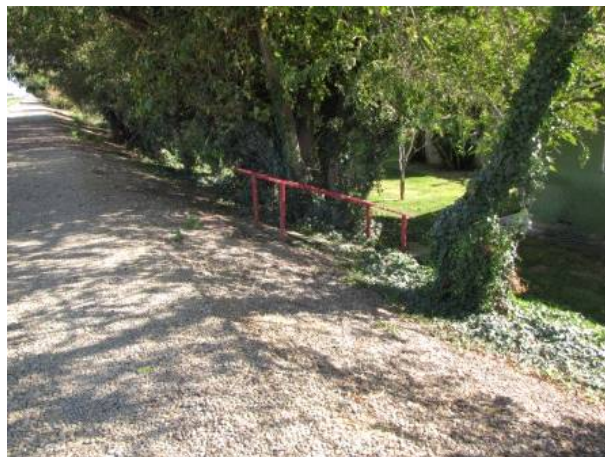
Levee Mile Report Line	75
Start Levee Mile	2.06
End Levee Mile	2.06
Location	Land Side
Category	Earthen Levee
Item	Encroachments

View of steps dug into the landward slope looking upstream.

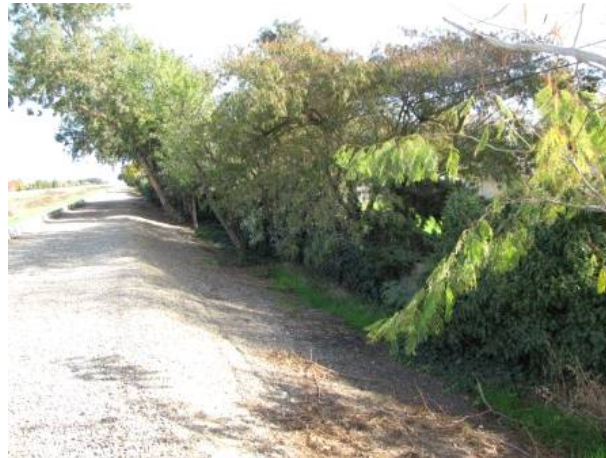
View of a fence with landscaping growing on it at the landward toe looking upstream.

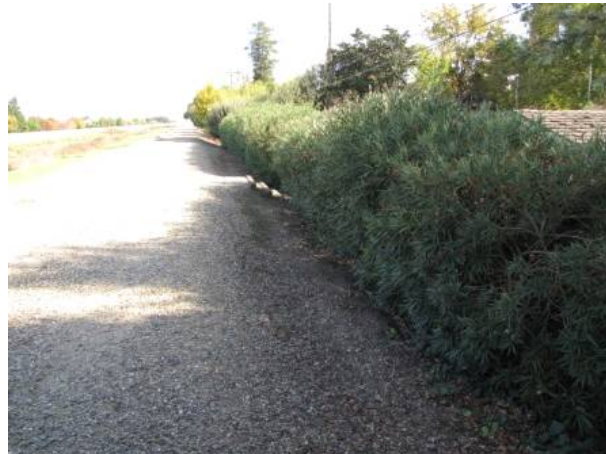
Levee Mile Report Line	79
Start Levee Mile	2.14
End Levee Mile	2.16
Location	Land Side
Category	Earthen Levee
Item	Encroachments

View of landscaping along the landward slope looking upstream.

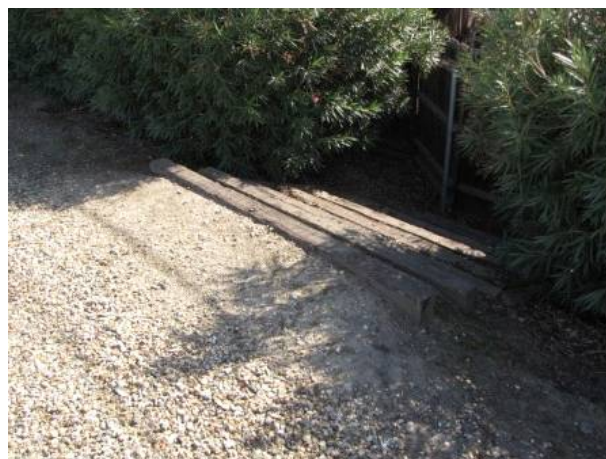
Levee Mile Report Line	80
Start Levee Mile	2.15
End Levee Mile	2.15
Location	Land Side
Category	Earthen Levee
Item	Encroachments

View of steps dug into the landward slope.
